### GEOTECHNICAL FIELD MEMO

CLIENT:	Adam Withers	DATE:	July 5, 2022
ATTN:	Adam Withers	FILE NO.	22-312
CC:	Derek Harding (D&H Excavating)	MEMO NO.	2
PROJECT:	Single Family Dwelling		
LOCATION:	Lot 31 Goldstream Heights, Malahat

PURPOSE: To review fully exposed subgrade and give recommendations for compaction.

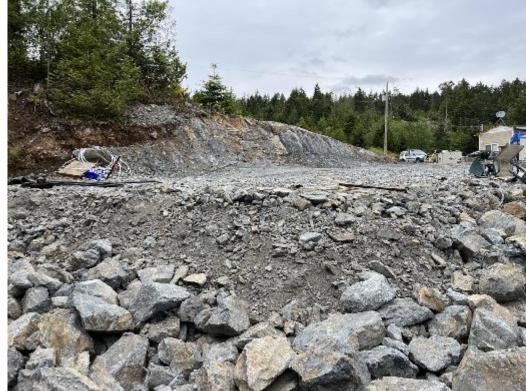
# Photo 3:

Final compaction by contractor.
