SHAWNIGAN LAKE QUARRY RESTORATION PLAN

Prepared for
Land Owners & Cowichan Valley
Regional District

Prepared by
Fiona Dalrymple
December 2010

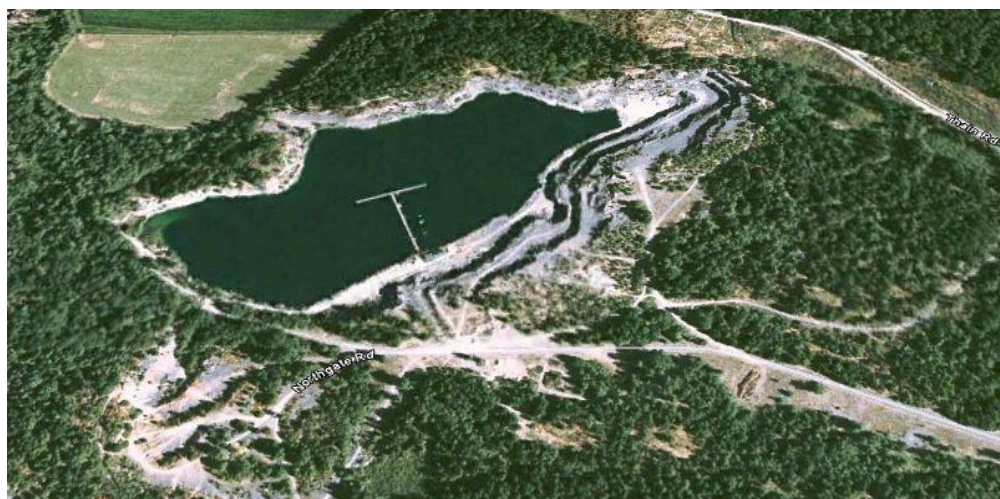
Figure 2 Aerial view of Kingzett Lake (Google Maps, 2010)

Historically, the land was owned and used by the BC Cement Company as a source of limestone. A large open-pit mine was established in 1953 and multiple cement roads were paved in order to transport rock to the Bamberton manufacturing site (Bamberton Historical Society, 2010). During this process, pumps were needed to remove water flowing in from aquifers. When the company shut down in 1980, the pit (rumoured to still contain equipment) was allowed to fill with water (creating Kingzett Lake) (Shawnigan Lake Museum, 2010). Following this, a fish farm was established on the body of water for a short period of time (Fig. 2).

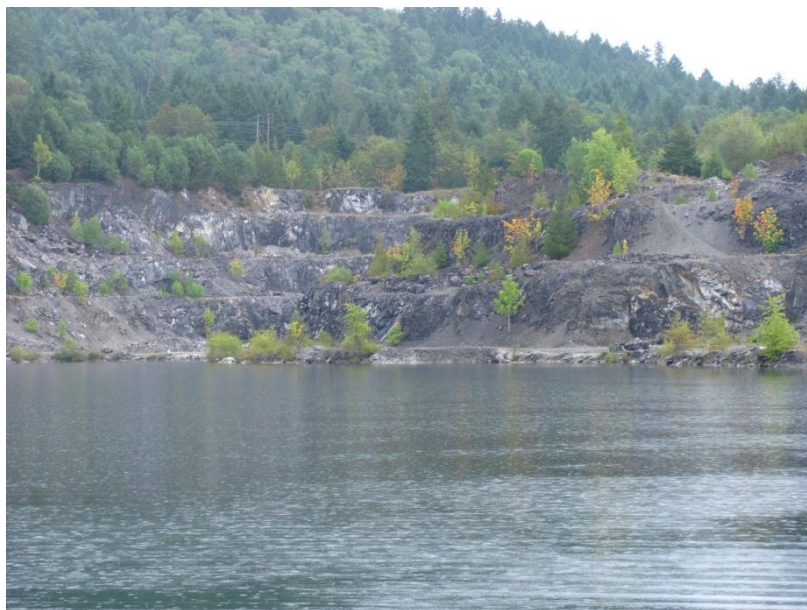
Figure 3 Walking trail along perimeter of Kingzett Lake

Currently the 568 acres are privately owned through 11 different but contiguous legal titles and used by the public for recreation (Fig. 3). In 2005, the owners applied for rezoning (from F-1-Primary Forest) to develop a large

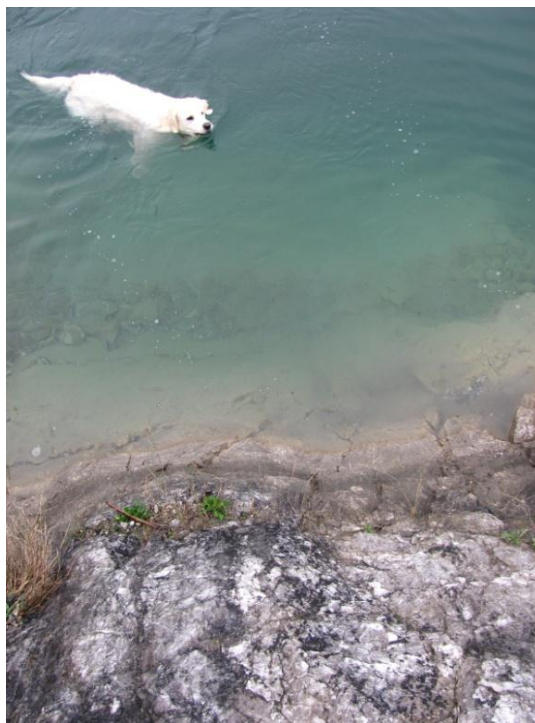
Figure 4 Lack of vegetation and steep, weathered banks around lake

for suitable successional ecosystems. Ecosystem functions targets must also be established in order to meet the needs of the Shawnigan Lake human population. When a community is involved in setting and achieving these targets it will likely feel more dedicated to maintenance and protection. The ecosystem functions target for this site is the development of an ecosystem that functions as a low-impact recreational area because it is already highly valued for this type of use (Fig. 4).

Cement road construction (Fig. 4)	Habitat fragmentation resulting in low wildlife density. Compaction resulting in lack of soil biota, low porosity, and slow water infiltration/ filtration rate. Plants unable to establish; water runoff during heavy rain causing erosion; biodiversity low. Previously hydro-seeded agricultural grasses and legumes along haul road preventing natural succession trajectory for this area.
Logging to clear mining site and areas for trucks and machines	Compacted, nutrient deficient soil colonized by abundance of invasive species such as <i>Cytisus scoparius</i> (Scotch Broom), <i>Rubus discolor</i> (Himalayan Blackberry), and <i>Hypochaeris radicata</i> L. (Hairy Cat's Ear). Active rill, sheet and raindrop erosion occurring. Hydro-seeded grasses along road and other large areas are preventing other plant species, such as <i>Alnus rubra</i> , from establishing
Dispersion of limestone dust in dry, summer months due to wind (often covers plants on edges of trails)	CaCO ₃ dust decreases photosynthesis efficiency when coating leaves (Cook <i>et al.</i> , 1995). Dust can also cause respiratory irritation in humans and other wildlife (USDL, 2010). Deposition can create hardened pockets of soil after heavy rains preventing plant growth.

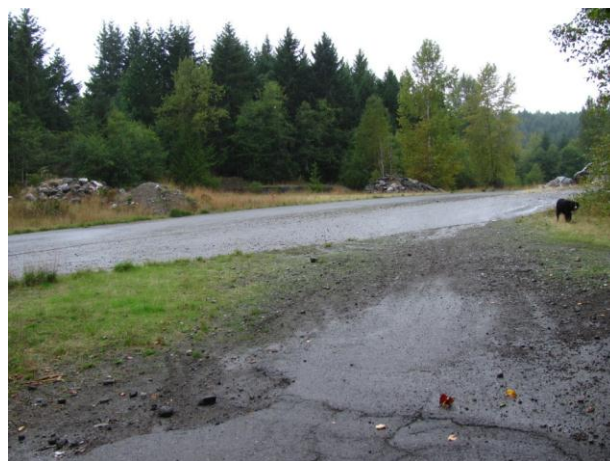
Figure 5 Cement haul road

1. The treatment that would be most widely implemented at this site is the establishment of rough and loose earth. Using an excavator, large tracts of soil could be turned in order to decrease compaction and serve as the first level of defence against erosion. In almost all target areas (except those that would become trails and pathways), this treatment would be used to increase the likelihood of native plant colonization, reduce impacts of erosion and provide a hospitable area for plantings. The old, cracked cement haul road (Fig. 5) would be removed and this treatment would be used on the compacted soil beneath.

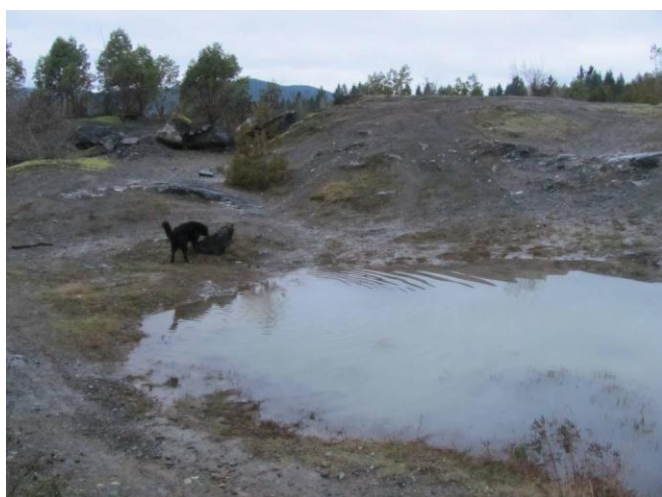
Figure 6 4x4ing area (major compaction and minimal biodiversity)

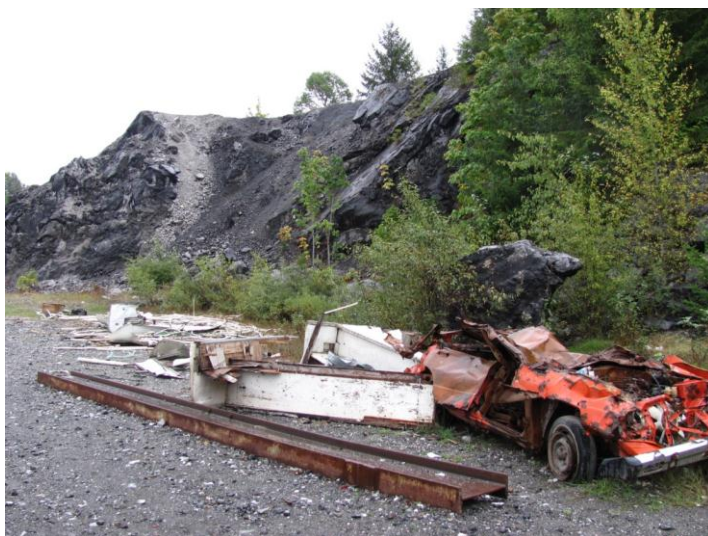
Figure 7 Garbage from active quarry site

5. Removal of all trash will also be a priority. Garbage surrounding the burned structure next to the lake would be removed (Fig. 7). During the process of making soil rough and loose, it is predicted that a great deal of garbage will be unearthed and will have to be trucked away from the site. Not only will this help the ecosystem to recover, but also make it safer for people using the space.

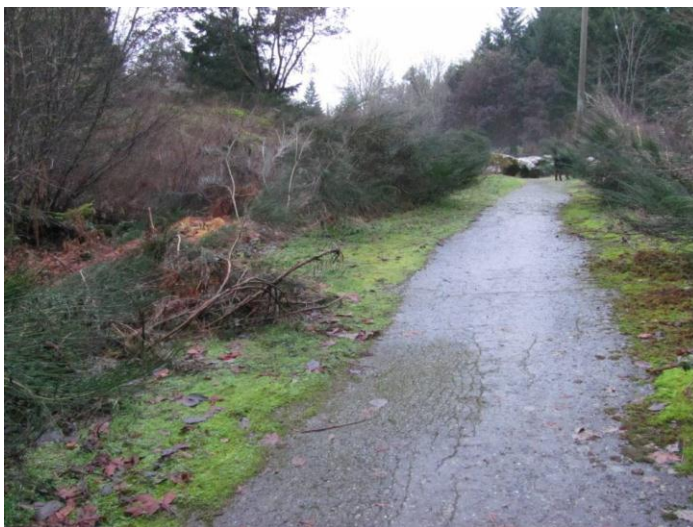
Figure 8 Broom colonizing disturbed areas

Scotch broom is well established in all previously logged areas (Fig. 8). Removal of this plant is essential to re-establishing a biodiverse, self-sustaining ecosystem. Scotch broom plants can be cut at ground level during or immediately prior to flowering. Choosing this stage in the plant's life cycle reduces the chance that seeds will spread and that the plant will be able to recover from its injuries during the hot, summer months. Upon removal, other native plant species should be densely planted in order to ensure that the

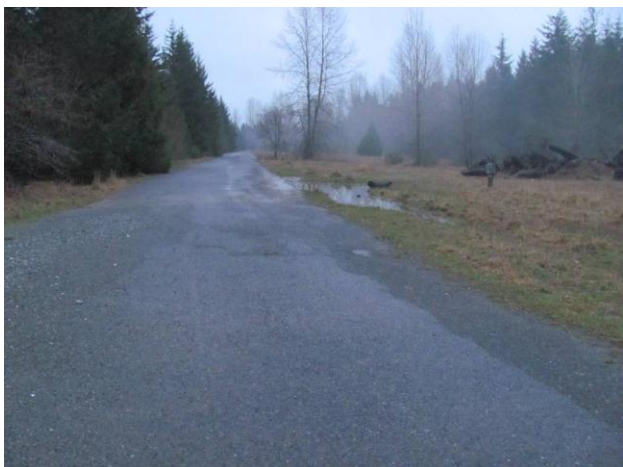
Figure 9 Agronomic grasses along haul road

broom will not be able to re-establish. Rapidly growing plants such as *Alnus rubra*, *Acer Macrophyllum* Pursh., *Gaultheria shallon*, and *Mahonia nervosa* would provide dense shade that would kill this shrub (Polster, 2004). The same technique should be used for removal of blackberry bushes (Fig. 10). Along roadways, where agronomic grasses were hydroseeded, the soil should be made rough and loose by an excavator and seeded with *Alnus rubra* (Fig. 9). Other plants, such as those mentioned above, could also

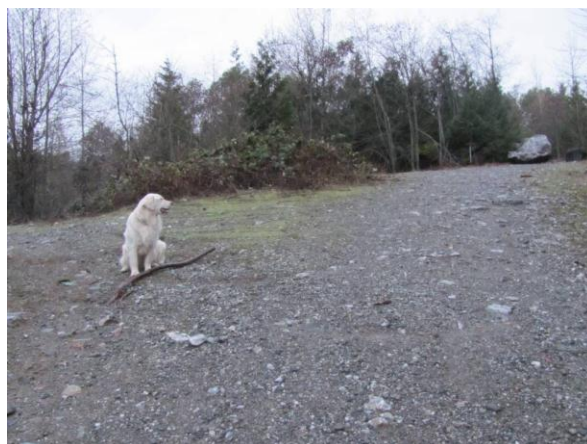
Figure 10 Blackberry colonizing disturbed areas

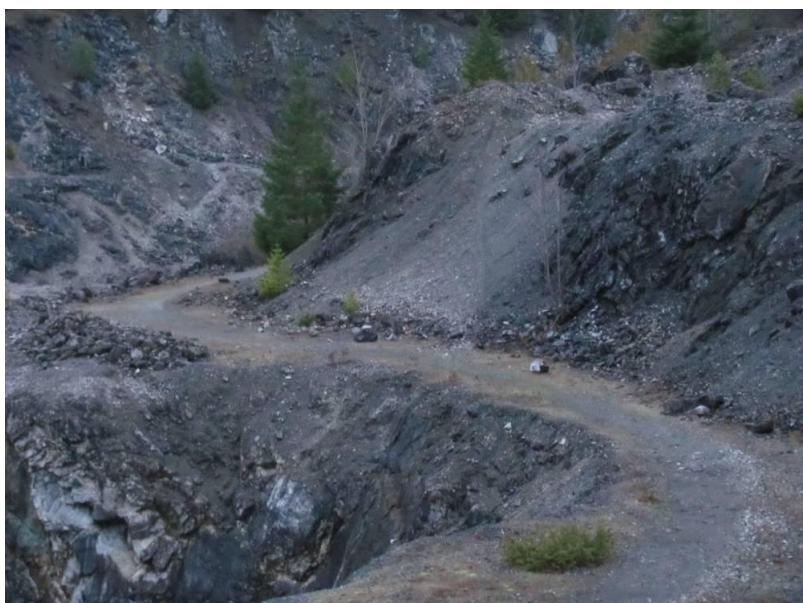
Figure 11 Steep slopes surrounding lake

- Pocket planting of cuttings, seedling plugs and seeds in steep areas can prevent erosion (Fig. 11). Species such as *Salix scouleriana*, *Alnus rubra*, *Cornus stolonifera*, *Holodiscus discolor*, *Populus trichocarpa* and *Arctostaphylos uva-ursi* can be planted in soil placed between rocks to stabilize the slope and eliminate erosion.
